Maine Department of Transportation Transportation Research Division

Technical Report 02-3

*The Use of Micro-Surfacing for Pavement
Preservation*

Interim Report - Second, Third, Fourth Year; December, 2005

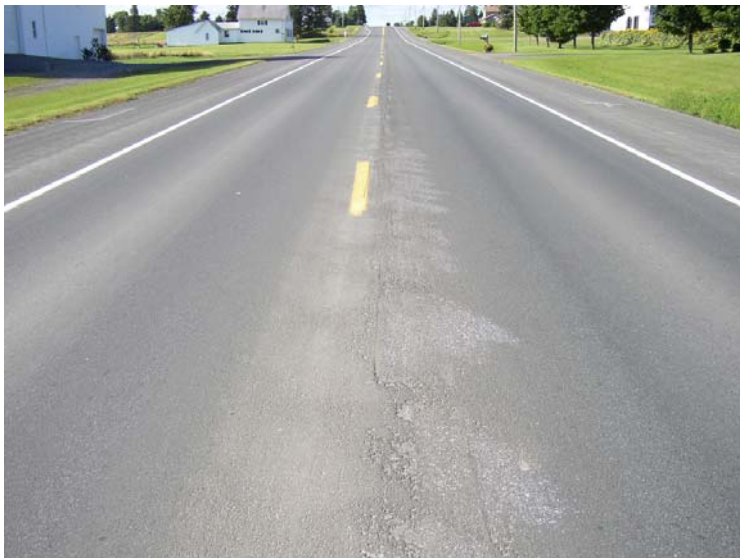
Photos 1, 2, and 3 are of Micro-Surface Section 1 taken in 2003, 2004, and 2005 respectively. It is apparent that the amount of centerline and quarter point plow abrasion has increased each year. Photo 2 displays areas in Section 1 where Micro-Surfacing has worn down to the original HMA surface. Another interesting observation is the herring bone plow wear pattern at centerline, a result of the plow skipping on the roadway during snow removal. By 2005 the quarter point has worn down to the original surface as displayed in Photo 3. Section 4, displayed as Photo 4, has similar wear patterns.

Photo 2: Section 1 Micro-Surface Centerline Plow Abrasion; August, 2004.

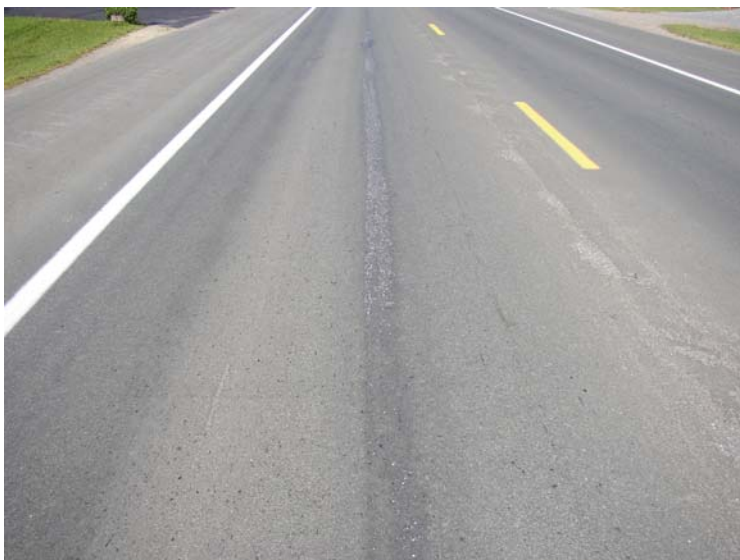
Photo 3: Section 1 Micro-Surface Centerline and Quarter Point Plow Abrasion; September, 2005.

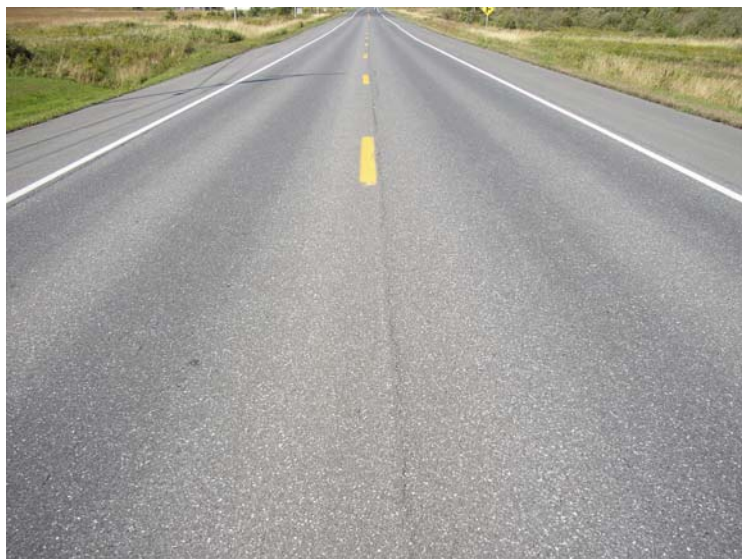
Photos 5 and 6 are of Control Sections 2 and 3 respectively. The surface looks very good and both sections have very little plow wear.

Photo 6: Section 3 Control Pavement Condition; September, 2005.

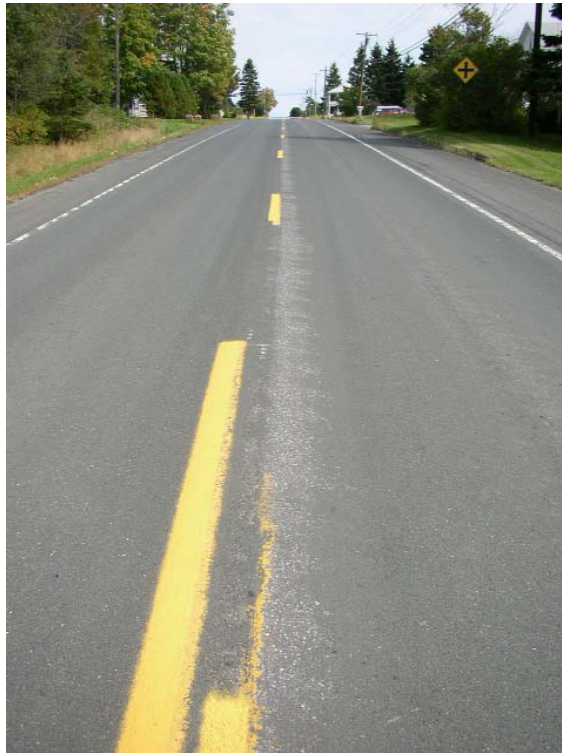
Plow abrasion on Section 5 of the Limestone – Caswell project is displayed in Photo 7 and 8. Abrasion at centerline has increased each year from 2003 to 2005. Photo 7 displays the amount of wear in 2003. In 2005 Micro-Surfacing has completely worn away exposing HMA surface the entire length of the section as displayed in Photo 8. Quarter point and shoulder joint abrasion is not as severe as compared to Sections 1 and 4.

Photo 7: Section 5 Micro-Surface Pavement Condition; September, 2003.

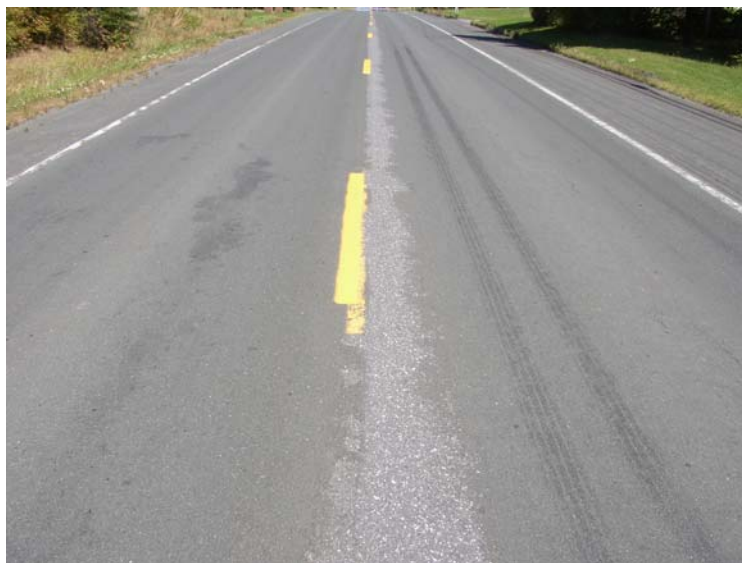
Photo 8: Section 5 Micro-Surface Pavement Condition; September, 2005.

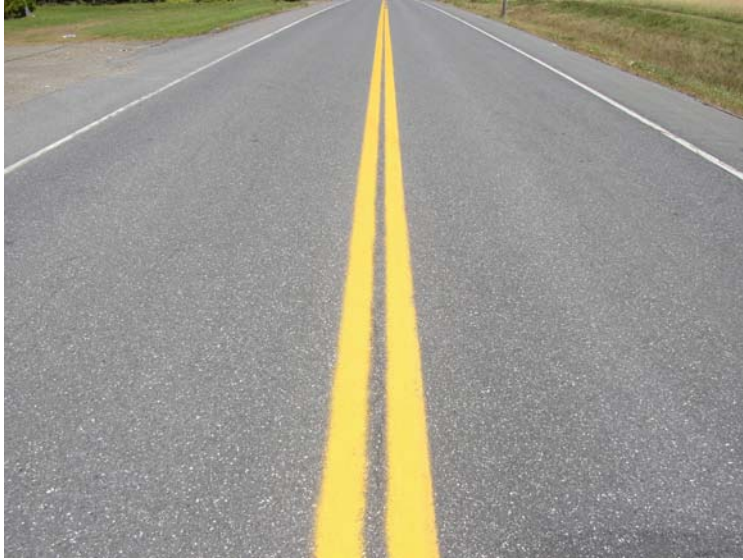
Control Section 6 has very little plow abrasion and looks very good as depicted in Photo 9.

Photo 9: Section 6 Control Pavement Condition; September, 2005.

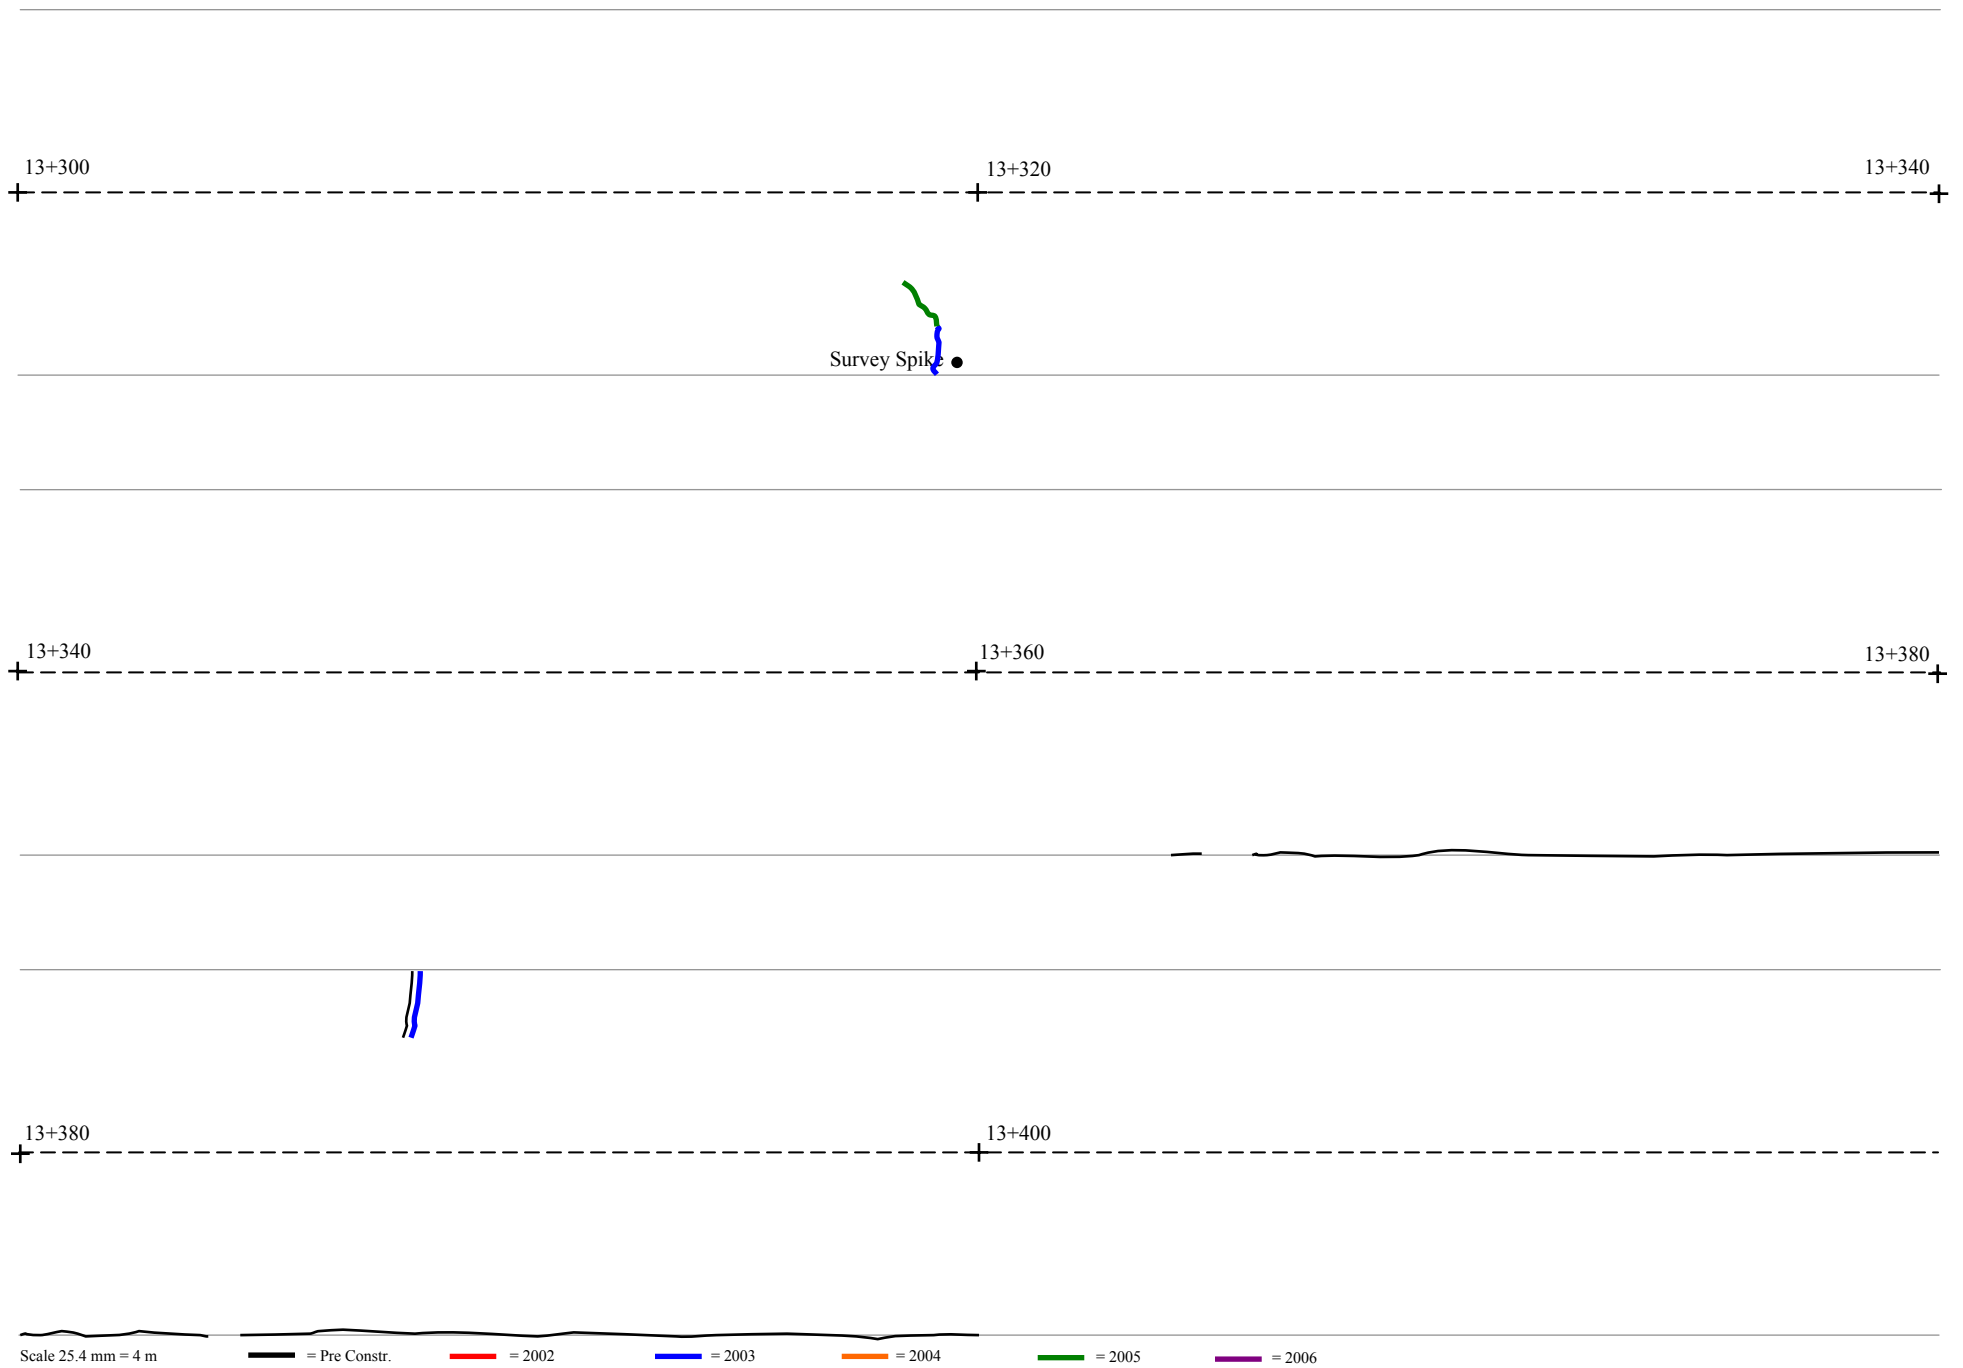
Figure 12. Section 1 Micro-Surface Crack Survey

Figure 12 contains a crack survey of Micro-Surface Section 1. This section had the lowest amount of preconstruction longitudinal cracking and only one partial transverse crack. The partial transverse crack reflected through and a new transverse crack appeared in 2003. No additional cracking was observed in 2004. In 2005 the new transverse crack at station 13+320 extended into the roadway to about midway across the lane.

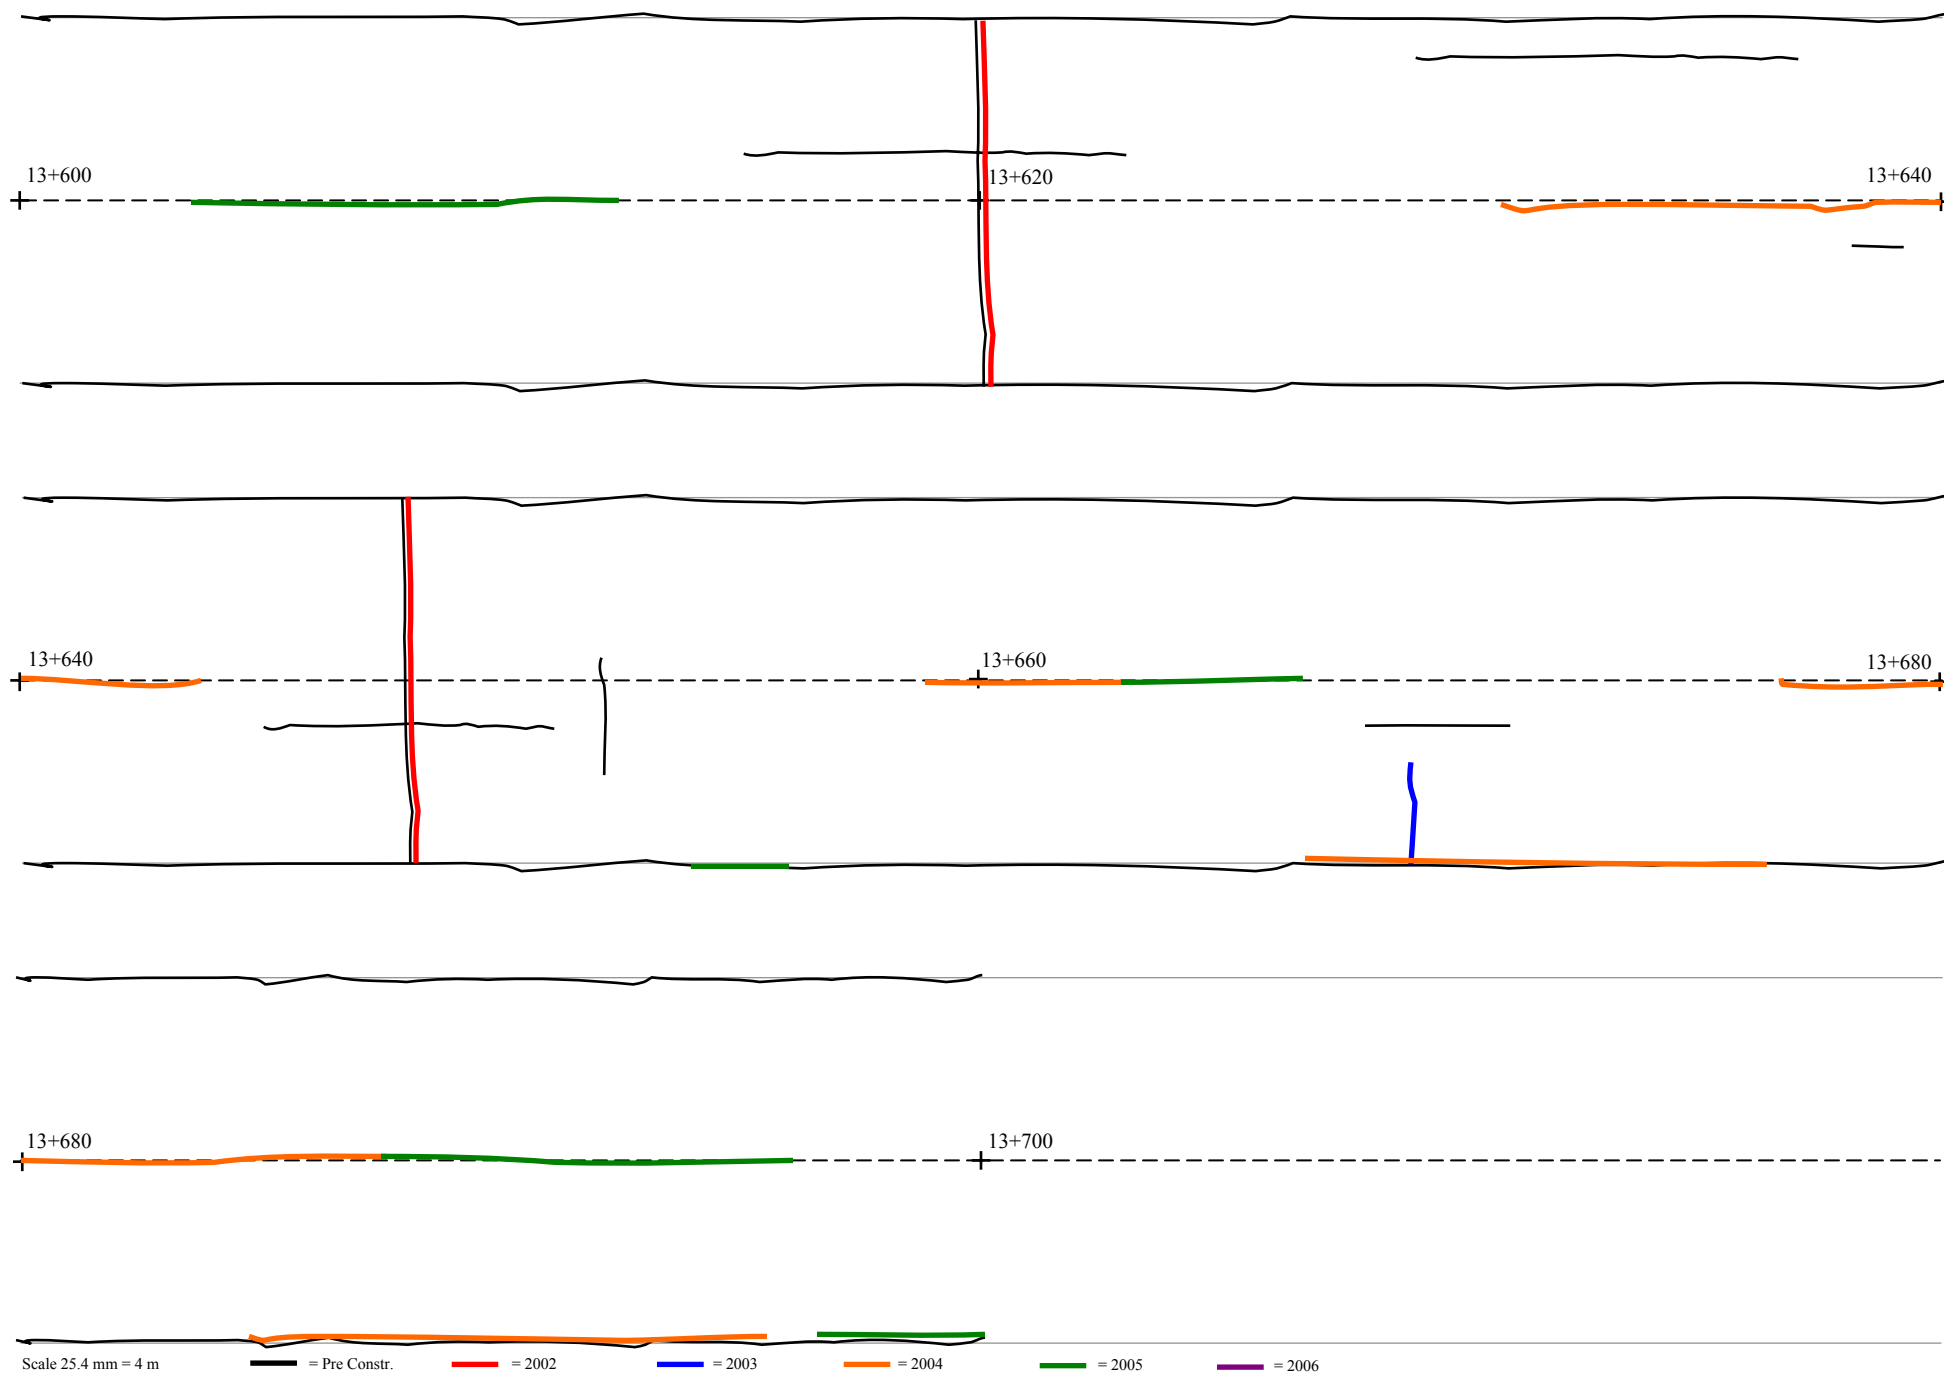
Figure 13. Section 2 Control Crack Survey

Figure 13 contains a crack survey of Control Section 2. A new transverse crack at station 13+670 was observed in 2003. In 2004 a portion of the shoulder joint had reflected through and new longitudinal cracking was noticed in much of the centerline. Additional centerline and shoulder cracking was noticed in 2005.

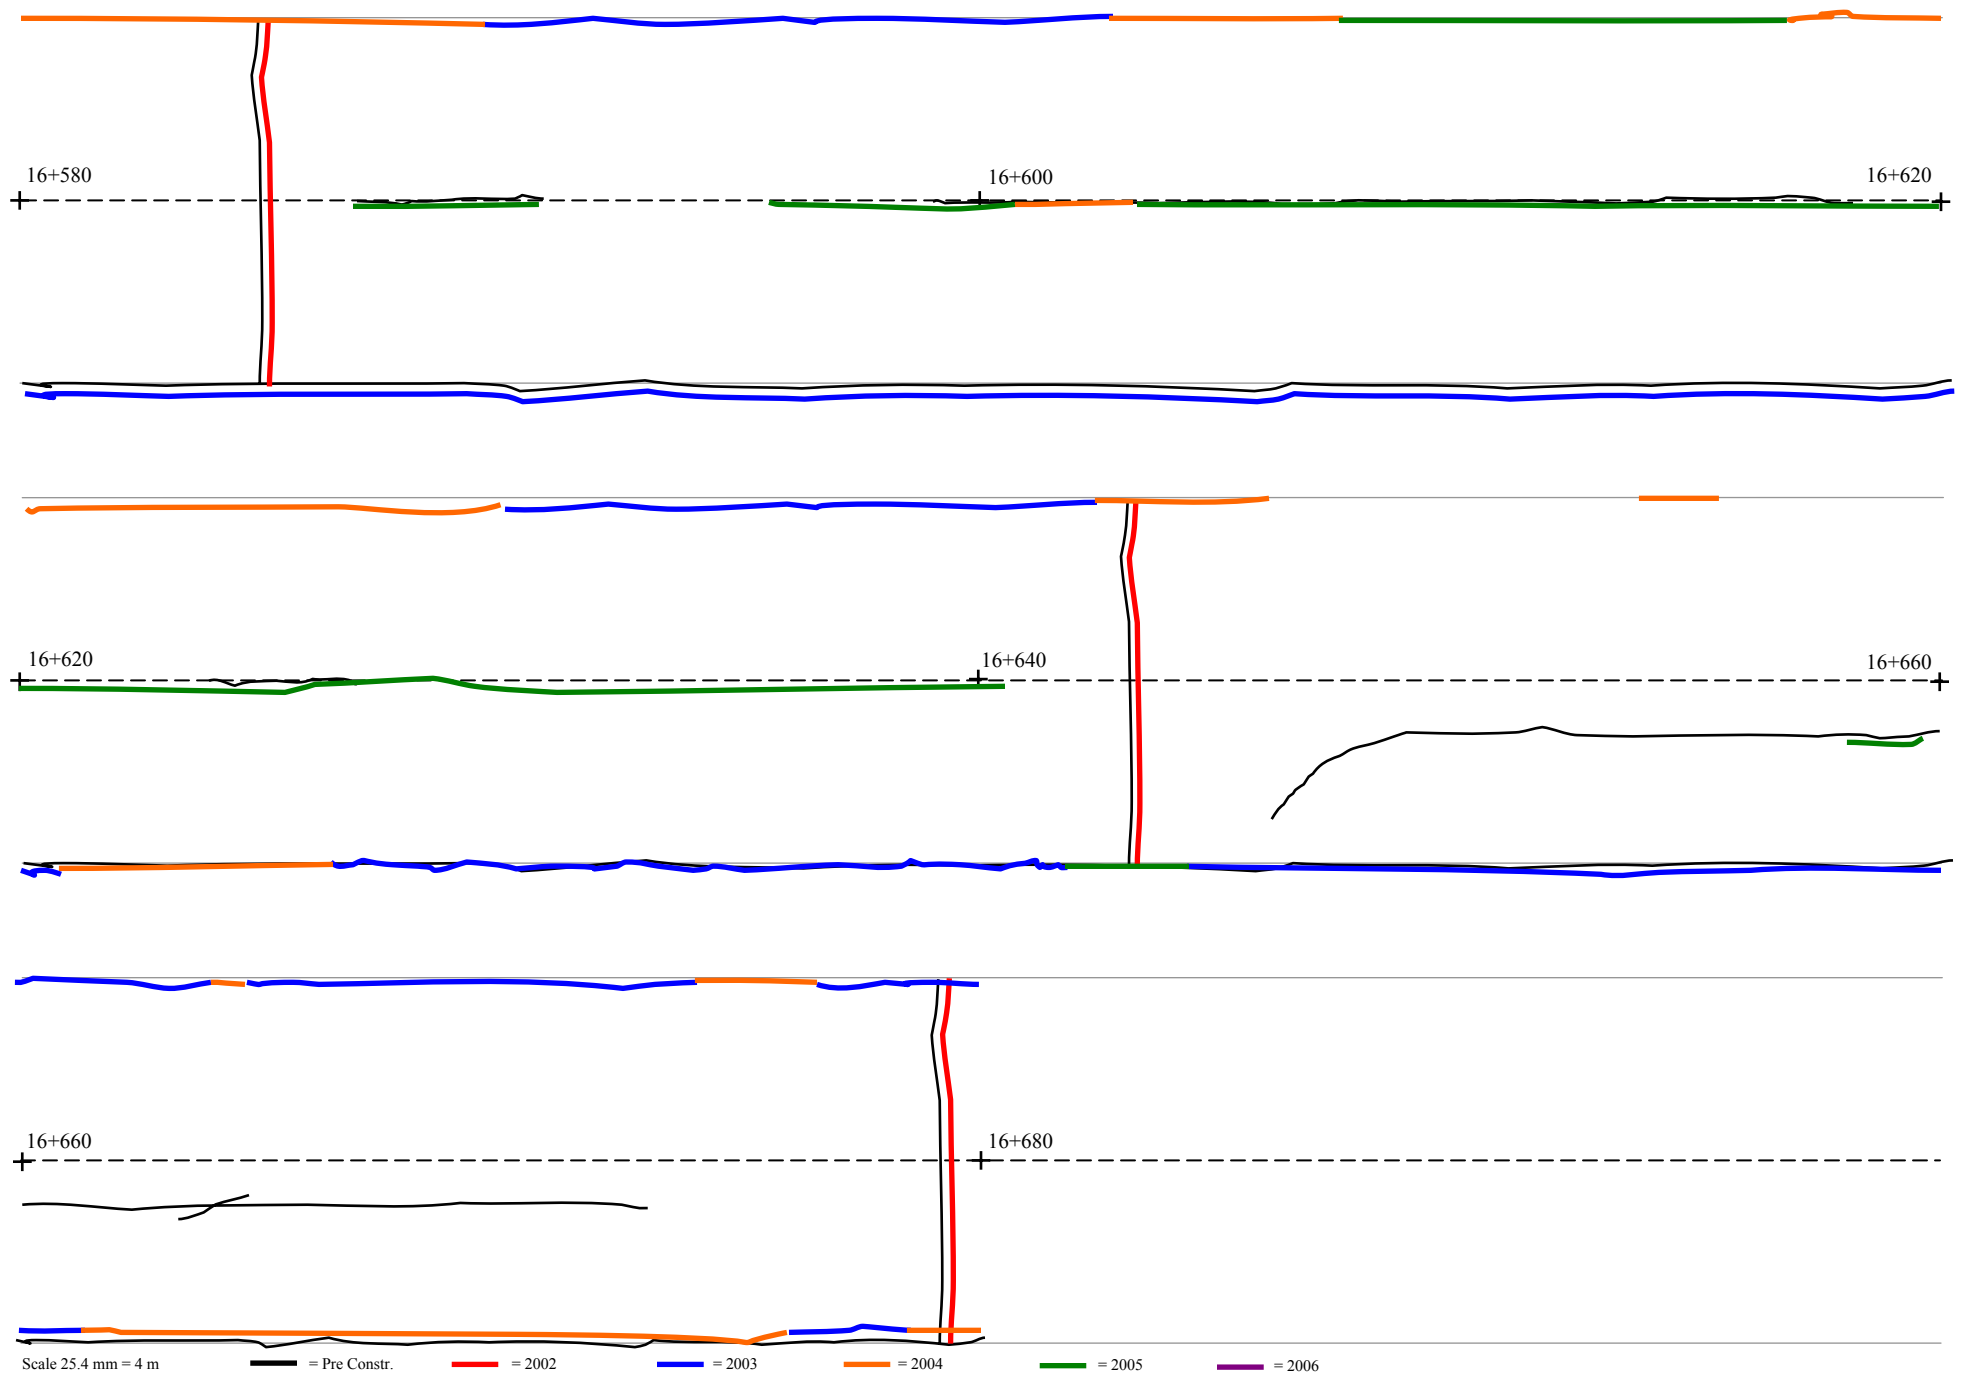
Figure 14. Section 3 Control Crack Survey

Figure 14 displays the amount of cracking on Control Section 3. No additional transverse cracking has been observed. Much of the shoulder joint has reflected through and a considerable amount of new shoulder joint cracking was observed in 2003. New and reflected shoulder joint cracking continued in 2004. By 2005 nearly all of the shoulder joint has cracked and all of the original centerline cracking has reflected through. New centerline cracking was observed on a third of the section. A small amount of longitudinal cracking in the wheel path is beginning to reflect through in 2005.

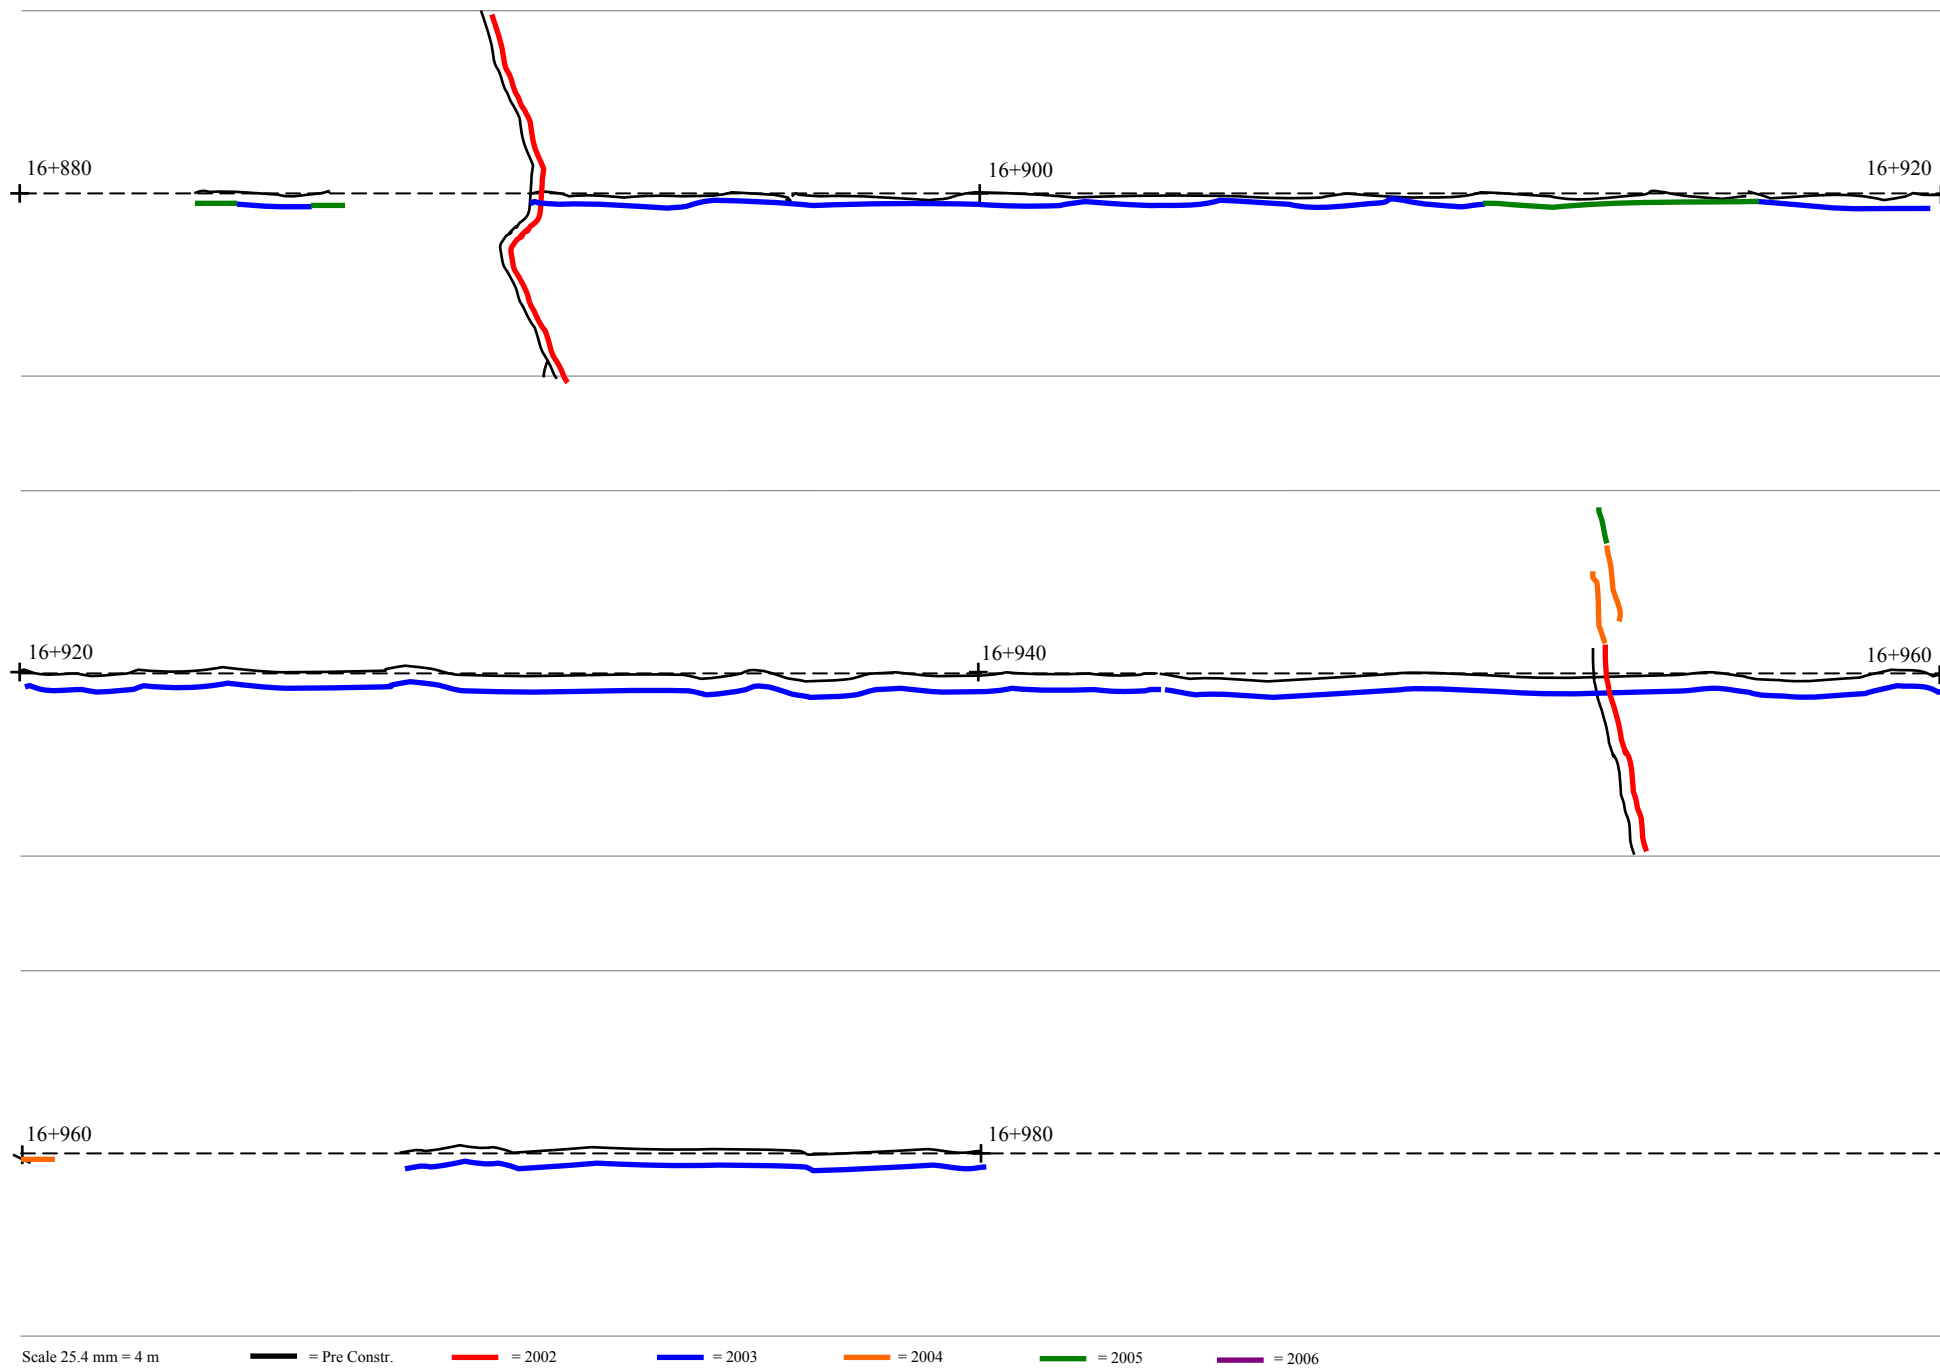
Figure 15. Section 4 Micro-Surface Crack Survey

Figure 15 contains a diagram of Micro-Surfaced Section 4. Most of the original cracks have reflected through in 2003. In 2004 only a small portion of new transverse cracking was observed at station 16+953. By 2005 all of the original cracks have reflected through.

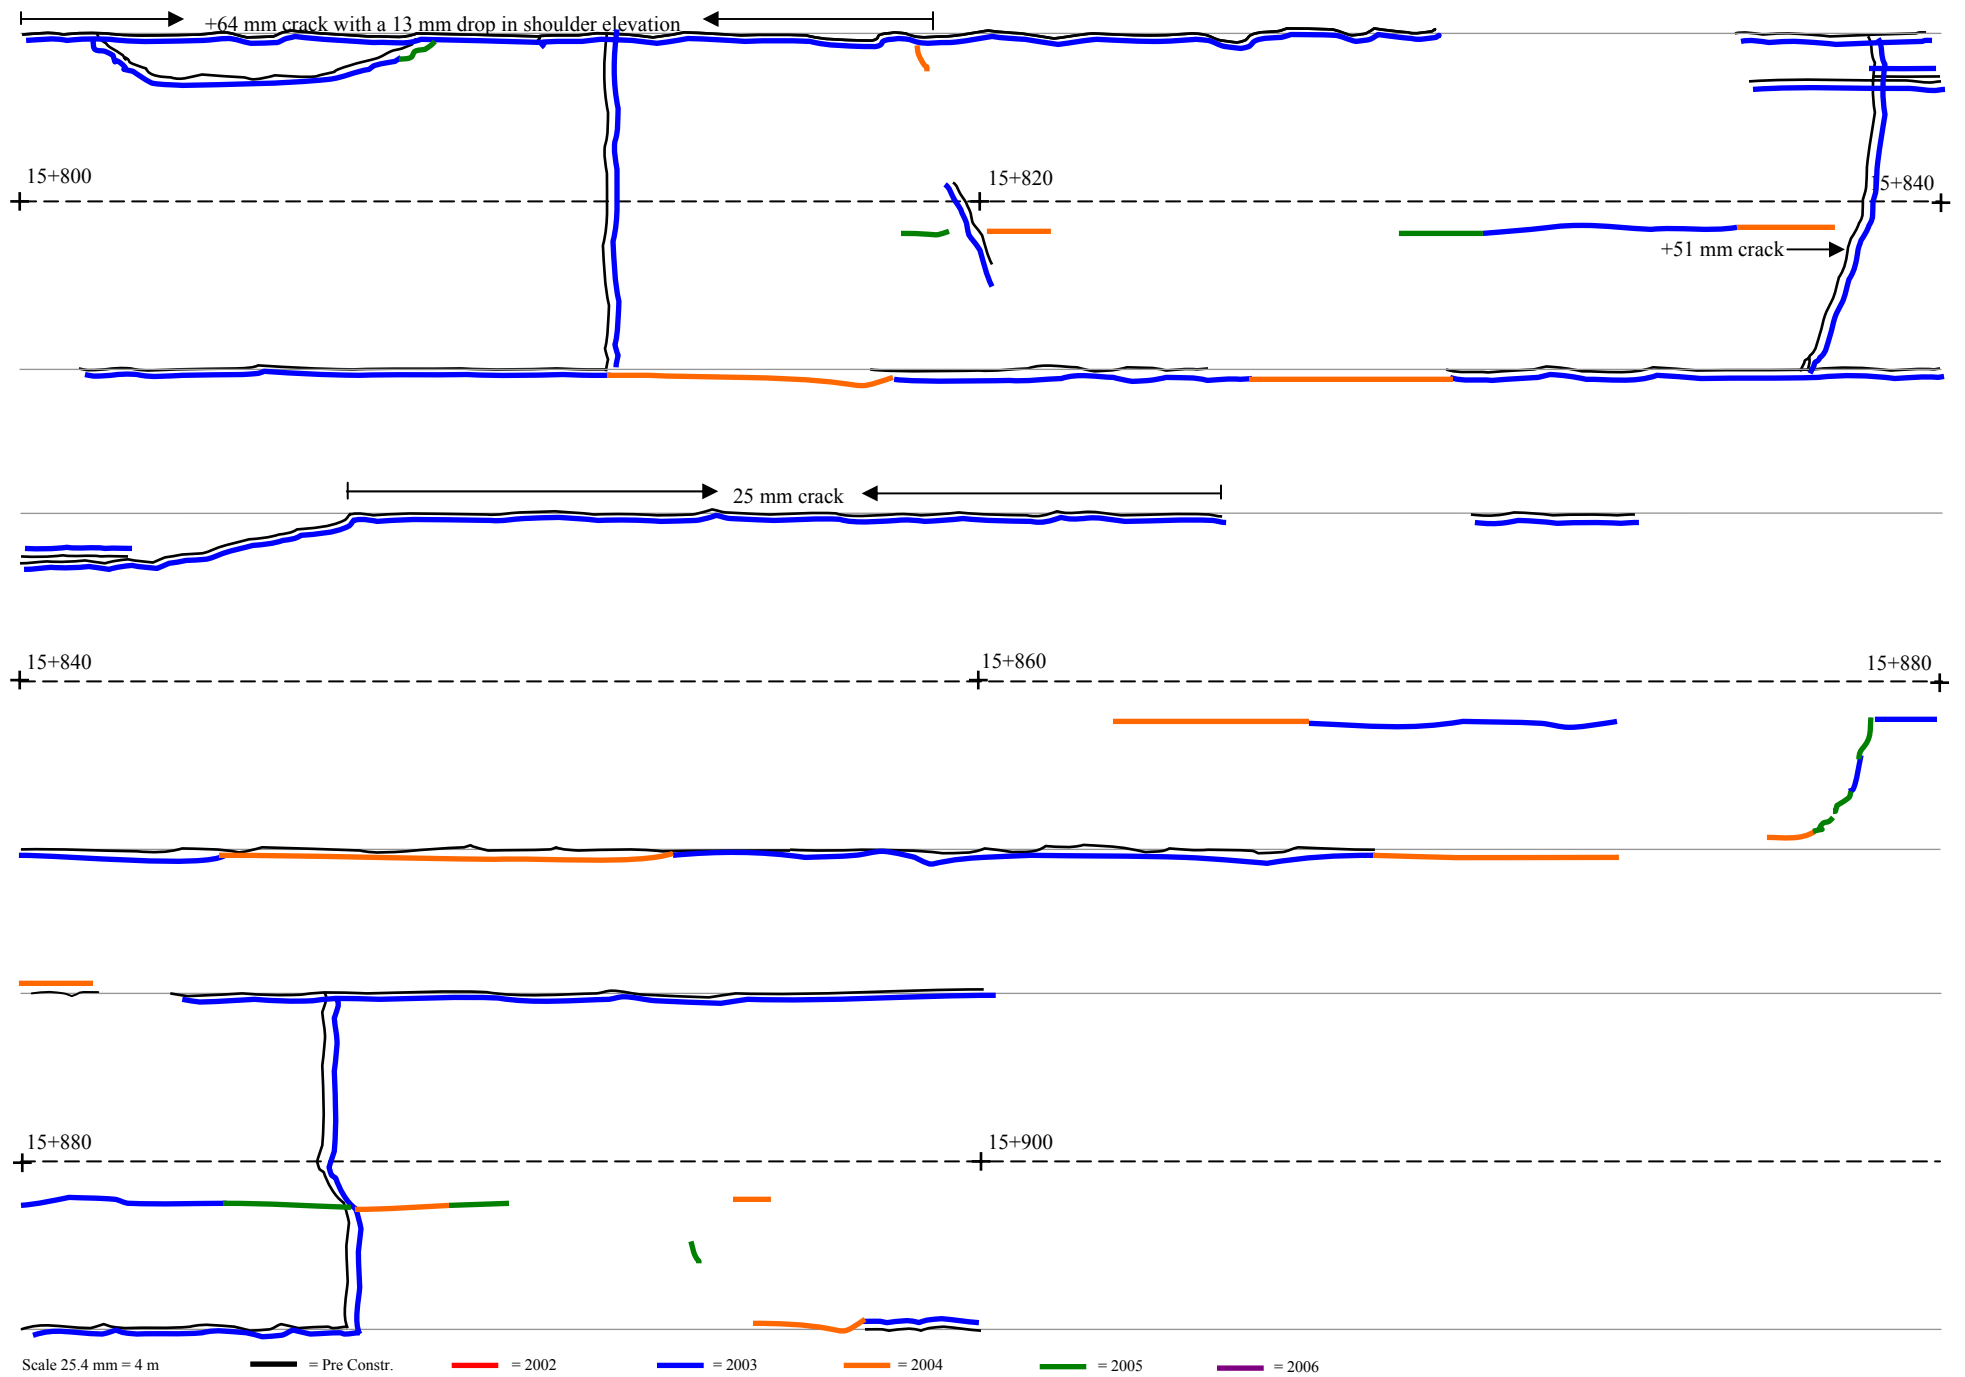
Micro-Surfaced Section 5 is displayed in Figure 16. A majority of the original cracks have reflected through in 2003 with a number of small areas of longitudinal wheel path cracking. By 2004 nearly all of the original cracks were visible and the longitudinal wheel path cracks were increasing. A few small areas of longitudinal and transverse cracks were observed in 2005.

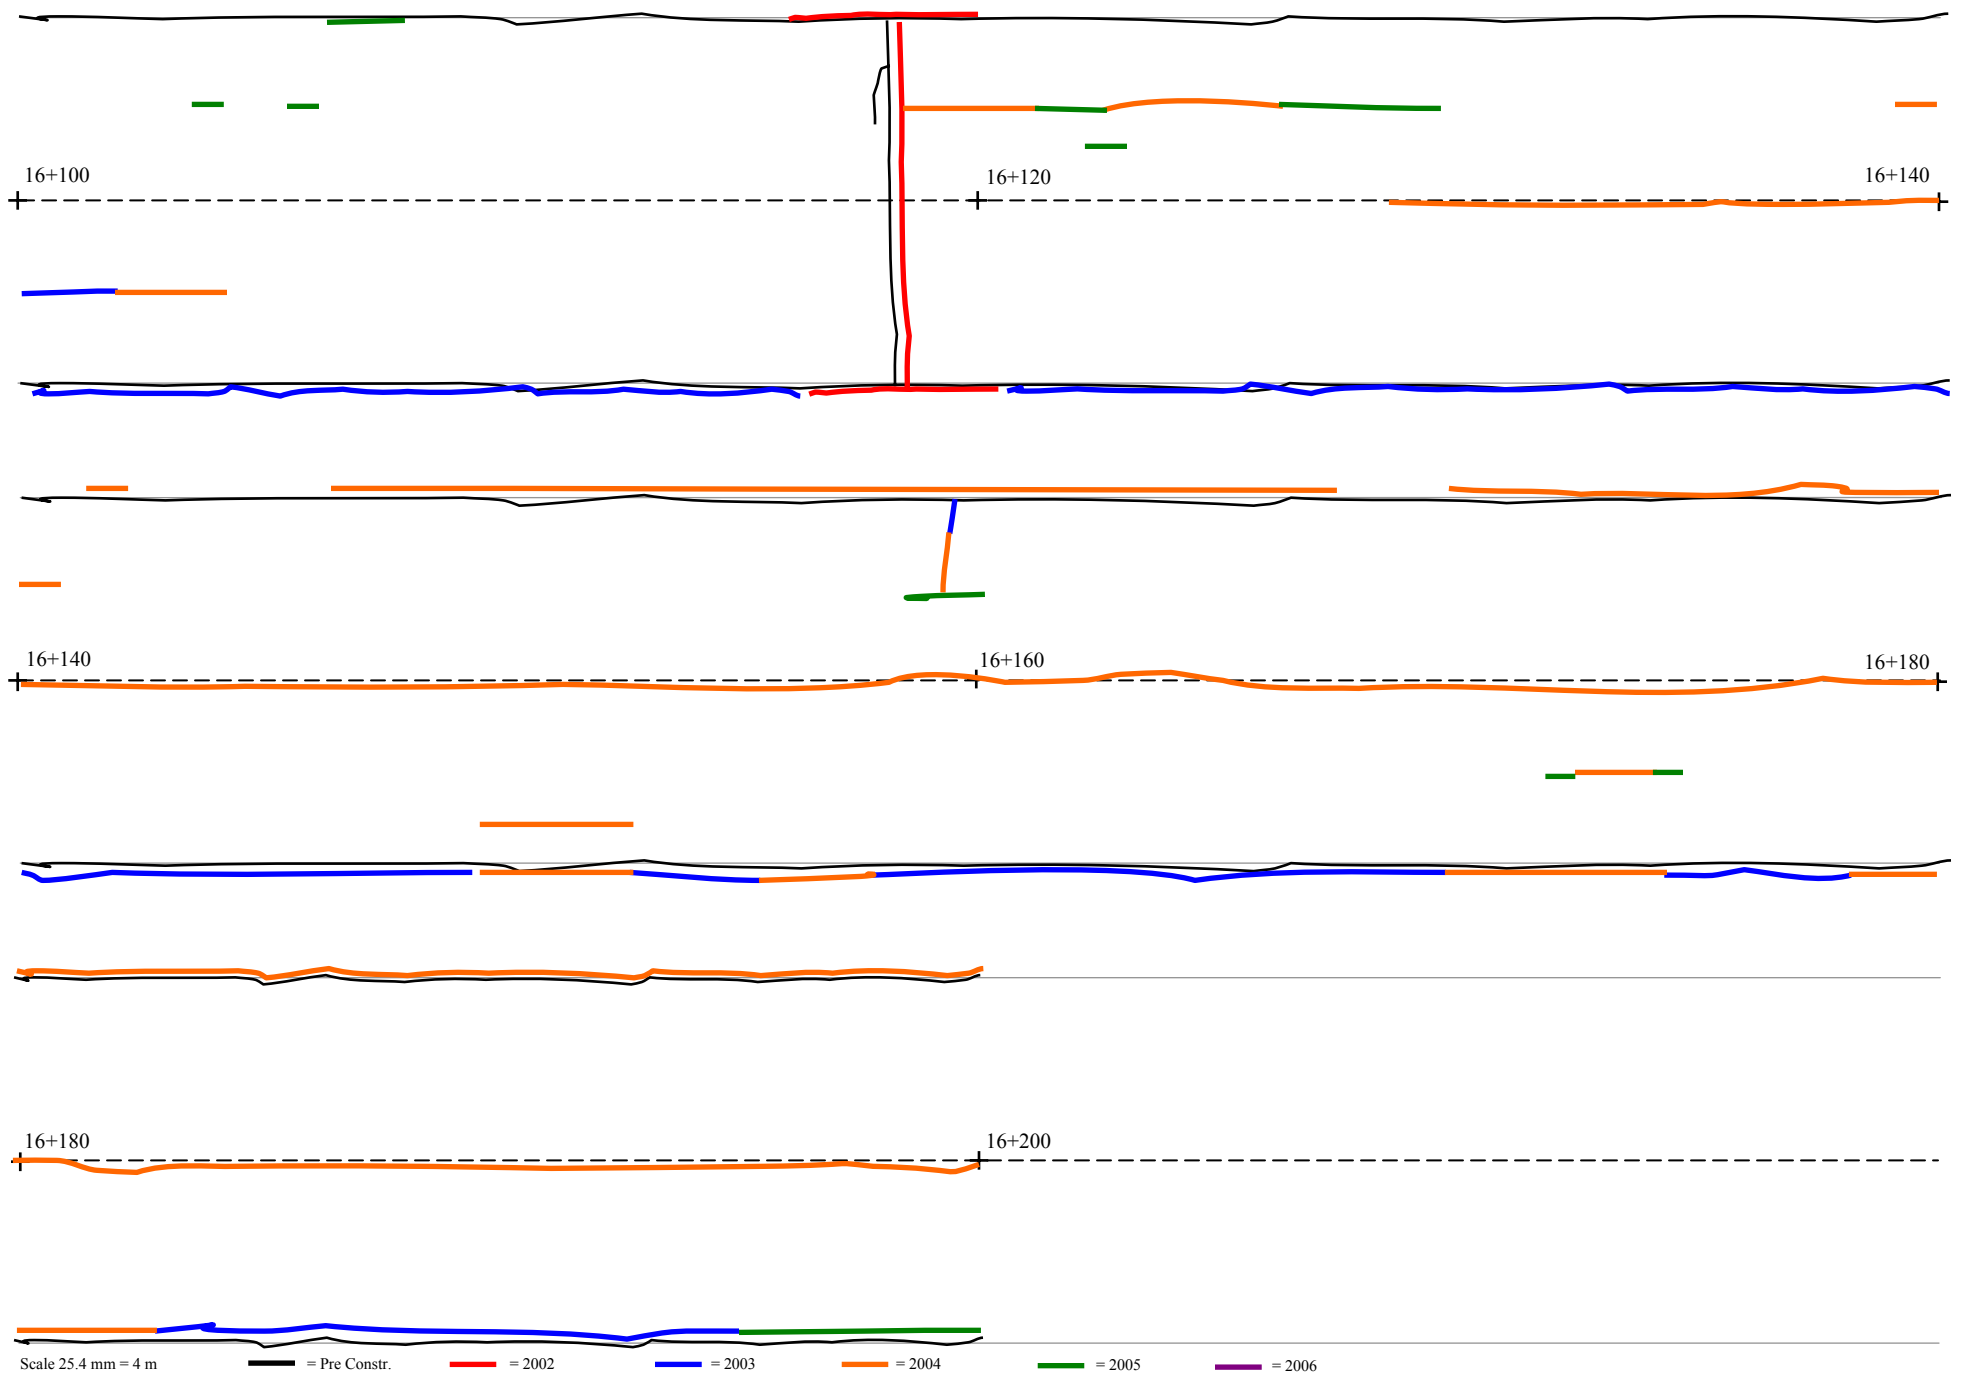
Figure 17. Section 6 Control Crack Survey

A crack survey for Control Section 6 is exhibited in Figure 17. In 2003 roughly a third of the shoulder joint has cracked and a transverse crack has begun to cross the roadway at station 16+159. By 2004 nearly three quarters of the shoulder and centerline joint has cracked and a few small areas of longitudinal cracking were observed between wheel paths and in the outer wheel path. The transverse crack at station 16+159 has extended to the quarter point. In 2005 there was a small increase of cracking at the shoulder joint and additional cracking between wheel paths and in the wheel path.
